## Minerals Inspection Report

Mine Name: Natural Buttes	Permit Number: S/47/0108	Mine Status: Inactive
Operator Name: Brown Brothers Construction	Inspection Date: 03/15/2016	Permit Fees: Paid
Inspector(s): A. Abate	Inspection Time: 10:30	Bond Amount: \$52,200
Attendee(s): Ellis Brown	Weather: Clear 60F	Bond Escalation: 9/12/2017
Inspection Purpose: Routine Inspection		Prior Inspection: None

### Natural Buttes Mine M/47/0108

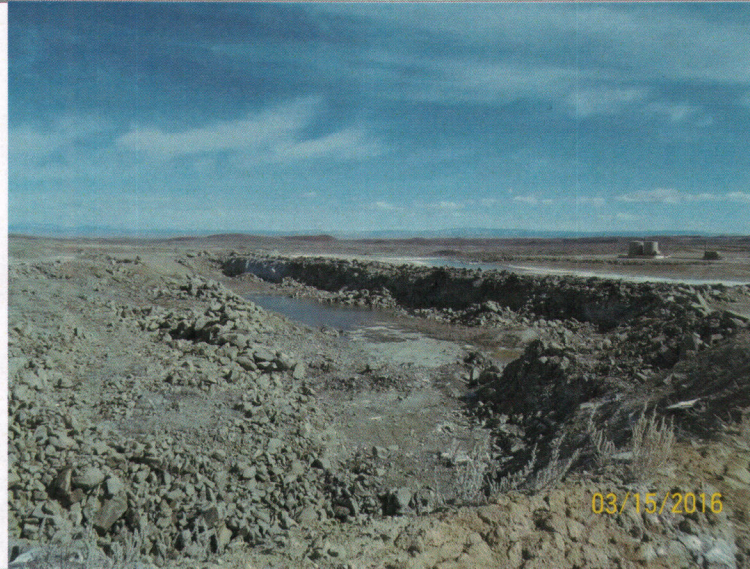
View of the quarry on the south side of the permit area facing northeast.

6. <i>Reclamation</i>	<input checked="" type="checkbox"/>	<input type="checkbox"/>
None observed to date		
7. <i>Backfilling/Grading (trenches, pits, roads, highwalls, shafts)</i>	<input checked="" type="checkbox"/>	<input type="checkbox"/>
The operator has expressed interested in keeping the permit under 10 acres by reclaiming areas and eventually mining to the east. A new map showing the mine plan will be required as an update to the Notice of Intent.

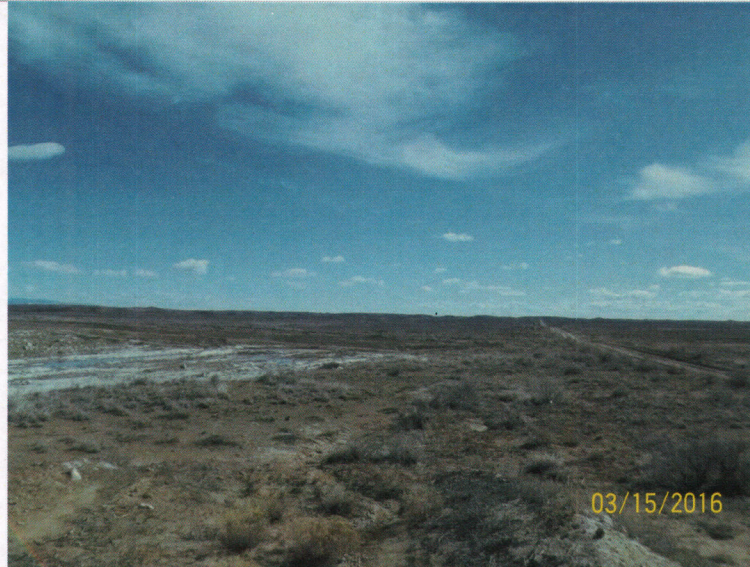
View of the 3.5-acre disturbance on the north side of the permit area facing east.

4. <i>Deleterious Material</i>	<input checked="" type="checkbox"/>	<input type="checkbox"/>
None observed		
5. <i>Roads (maintenance, surfacing, dust control, safety)</i>	<input checked="" type="checkbox"/>	<input type="checkbox"/>
The mine is directly adjacent to Seep Ridge Road. There is a second area of disturbance on the north side of the east-west road that bounds the quarry to the north. This area was calculated as 3.5 acres based on the GPS transect. The operator indicated that this area would be reclaimed and the portions of the quarry area to the south that exceed 10 acres.
